Report Number: 19-12895

ASBESTOS SURVEY OF CLIENT SPECIFIED AREAS ONLY OF

Chase Park, Whickham, Gateshead, Tyne & Wear, NE16 4EE

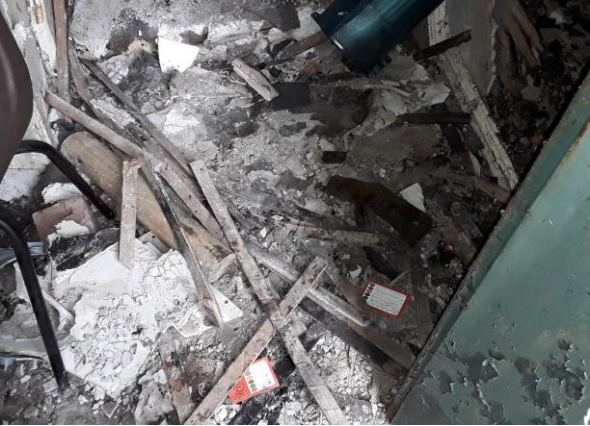
Room/Area: Floor G, Room 1 (Hall)
	Description: Floor (Residual adhesive)
	Sample Identifier: 19-12895-1
	Result: Chrysotile
	Notes:

CONCLUSIONS AND ACTIONS			
Room/Area where asbestos is present	Product/Item which contains asbestos	Recommended Actions	Urgency/Timeframe
1 (Hall)	Floor (Residual adhesive) - 19-12895-1	Monitor condition as part of management system	12 months
2 (Store)	Floor (Tiles & adhesive) - 19-12895-2	Monitor condition as part of management system	12 months

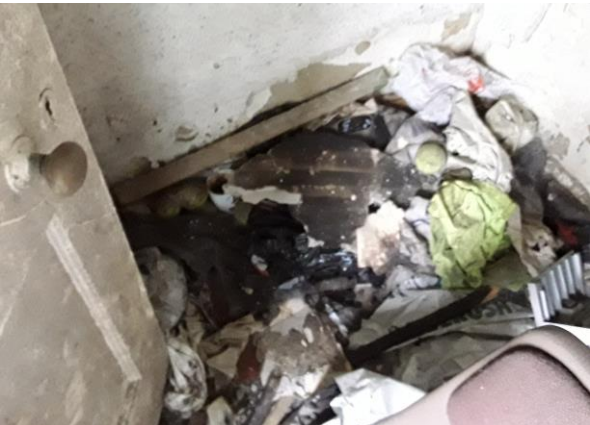
Room/Area: Floor G, Room 2 (Store)
	Description: Floor (Tiles and adhesive)
	Sample Identifier: 19-12895-2
	Result: Chrysotile
	Notes:

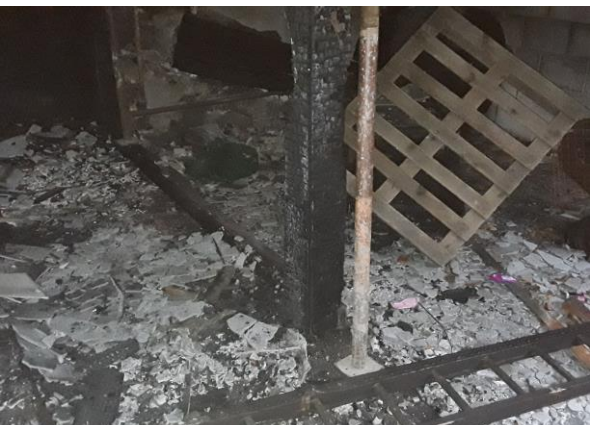
Room/Area: 3 (Garage 1)
	Description: Ceiling and associated debris to floor (Insulation board)
	Sample Identifier: 19-12895-3
	Result: No asbestos fibres were detected in a sample of this material
	Notes:

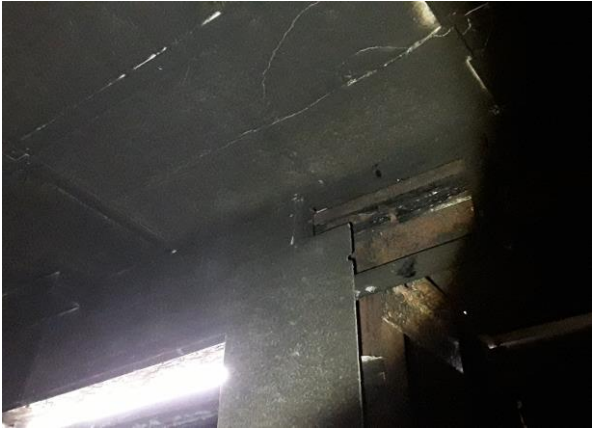
Room/Area: 4 (Garage 2)
	Description: Ceiling, fascia and associated debris (Insulation board)
	Sample Identifier: 19-12895-4
	Result: No asbestos fibres were detected in a sample of this material
	Notes:

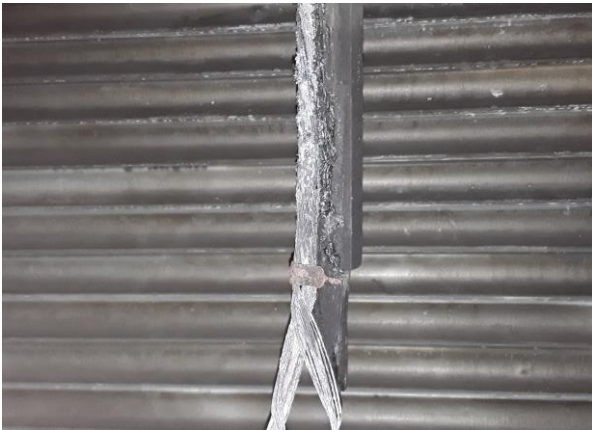
Room/Area: 4 (Garage 2)
	Description: Electrical cable sheath (Bituminous wrap)
	Sample Identifier: 19-12895-5
	Result: No asbestos fibres were detected in a sample of this material
	Notes:
