**A.M.I.S**  
**ASBESTOS SURVEY REPORT**

**Place:** Chase Park Centre

**Address:** Front Street  
Whickham

## 2.0 Management Summary

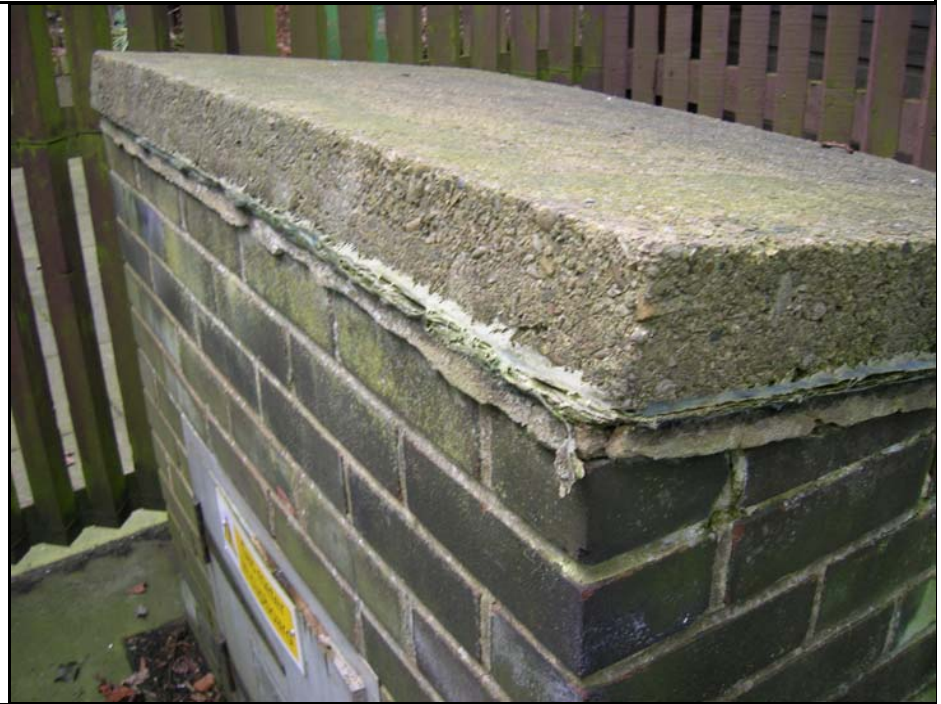
**Item No:** 40

**Description:** Insulating board slab roof to gas meter shed

**Product Type:** 2 - *Medium*

**Damage:** 3 - *High*

**Treatment:** 2 - *Medium*

**Asbestos Type:** 2 - *Other*

**Total Points:** 9

**Priority Assessment Total Points:** 1

**Combined Assessment:** 8

**Management Option:** Remove

**Timescale:** Within 12 months

**Priority:** Low
